Phone: (580) 351-0484
Fax: (580) 353-6326
haubrickhomeinspections.com

Standard Inspection Report For: John Doe

481 NE Windy Ridge, Lawton, Ok

Date of Inspection: 12/18/2018

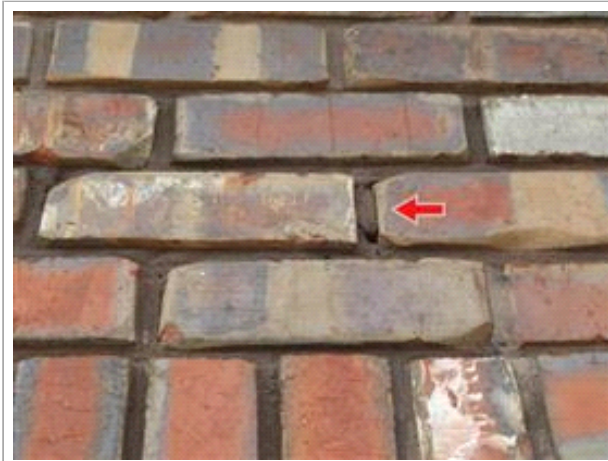
Figure Number 4

Deteriorated mortar noted at brickwork on exterior of structure. Due to settlement of structure, suggest re-pointing where needed. (See Figure #4) (See Figure #5) (See Figure #6)

Deteriorated mortar noted at brickwork on exterior of structure. Due to settlement of structure, suggest re-pointing where needed.

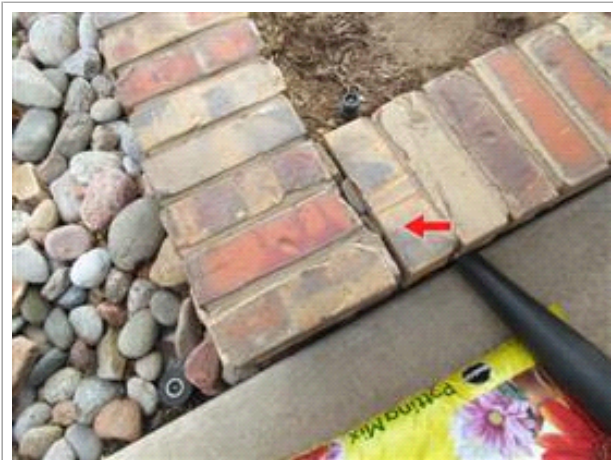
Figure Number 5

Deteriorated mortar noted at brickwork on exterior of structure. Due to settlement of structure, suggest re-pointing where needed.

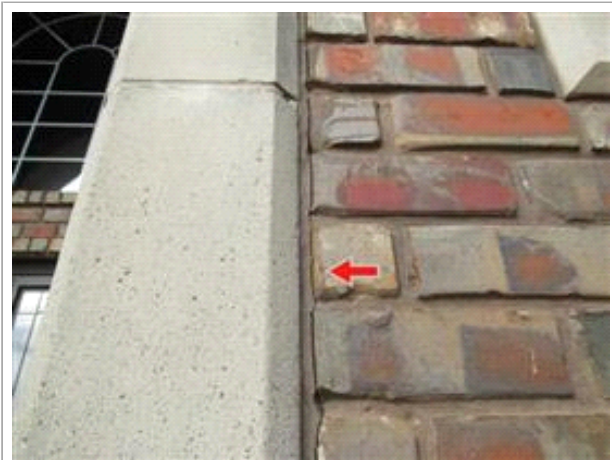
Figure Number 6

Deteriorated mortar noted at brickwork on exterior of structure. Due to settlement of structure, suggest re-pointing where needed.

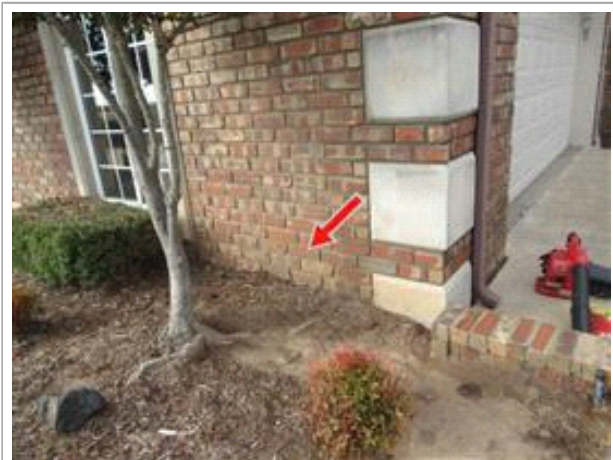
Figure Number 7

No weep holes at brick work. Evaluation by brick mason suggested.

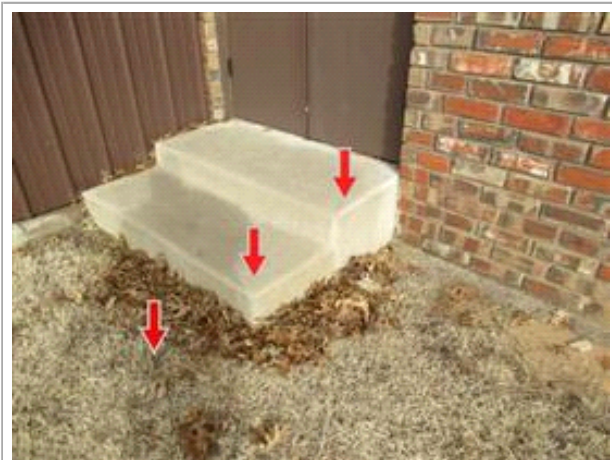
Figure Number 8

Hand rails are required at any steps that have two or more risers, hand rails are missing at the south mechanical entrance area. (See Figure #8)

Hand rails are required at any steps that have two or more risers, hand rails are missing at the south mechanical entrance area.

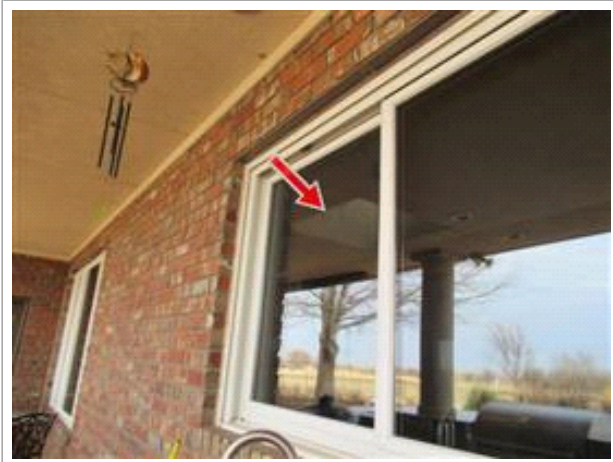
Figure Number 9

A few windows screens appear to be damaged or missing on exterior of structure. (See Figure #9)

A few windows screens appear to be damaged or missing on exterior of structure.

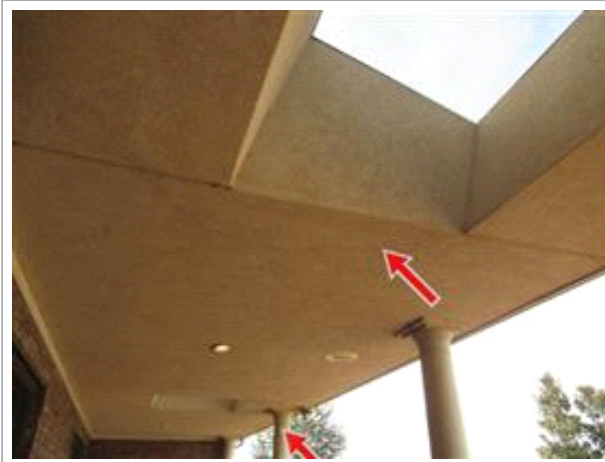
Figure Number 10

EIFS surface damage noted rear porch area along with prior leakage. No high moisture levels noted. Budget cosmetic repairs.

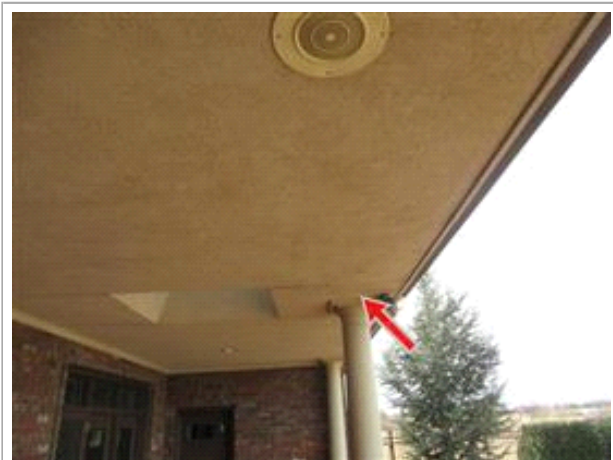
Figure Number 11

EIFS surface damage noted rear porch area along with prior leakage. No high moisture levels noted. Budget cosmetic repairs.

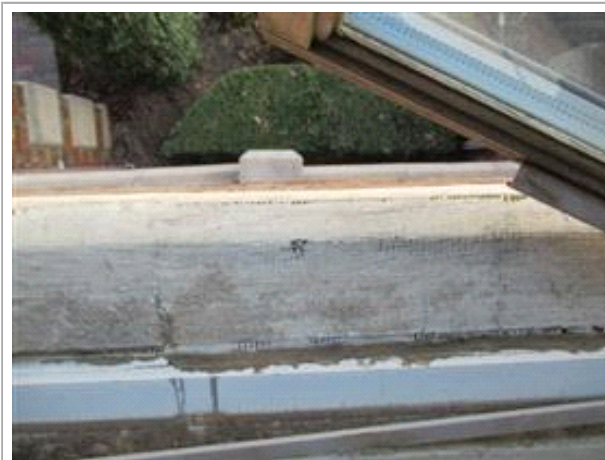
Figure Number 12

EIFS at second window plan-ons appear damaged & possibly allowing moisture intrusion. (See Figure #12)

EIFS at second window plan-ons appear damaged & possibly allowing moisture intrusion.

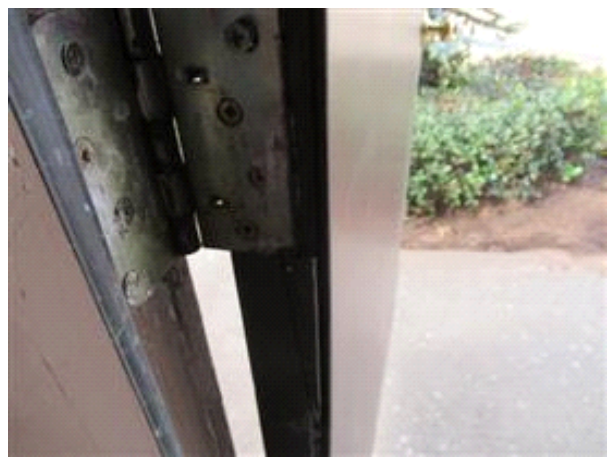
Figure Number 13

Wood decay/rot at rear exterior door trim on west side where door also appear to be damaged/cracked at hinges.

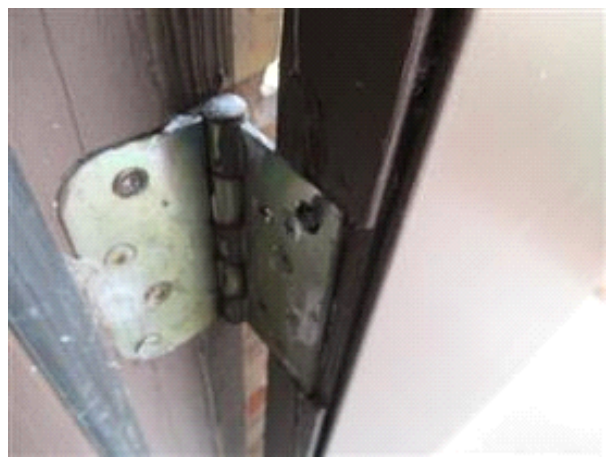
Figure Number 14

Wood decay/rot at rear exterior door trim on west side where door also appear to be damaged/cracked at hinges.

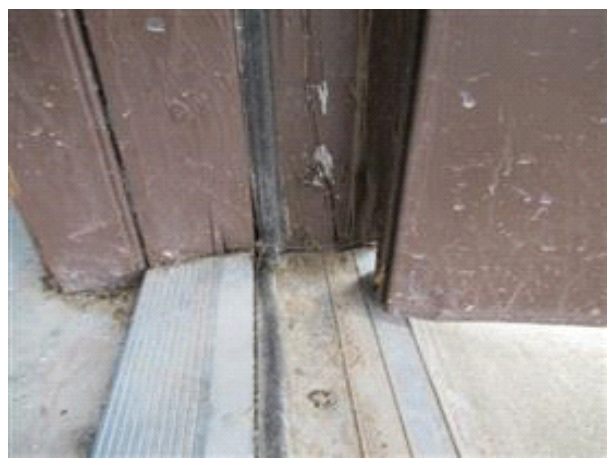
Figure Number 15

Wood decay/rot at rear exterior door trim on west side where door also appear to be damaged/cracked at hinges.

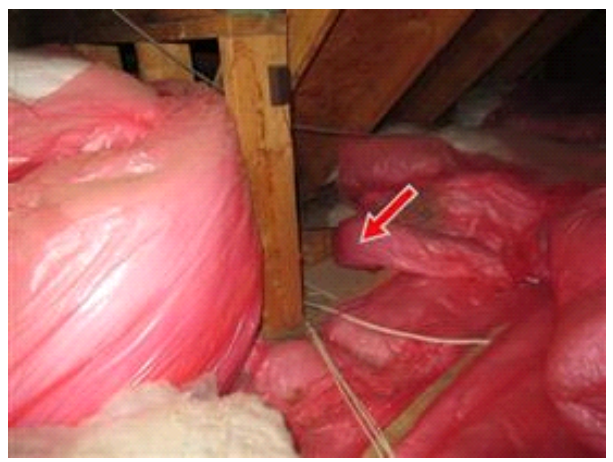
Figure Number 16

Dislodged /Missing insulation noted in attic area. Repair as needed. (See Figure #16)

Dislodged /Missing insulation noted in attic area. Repair as needed.

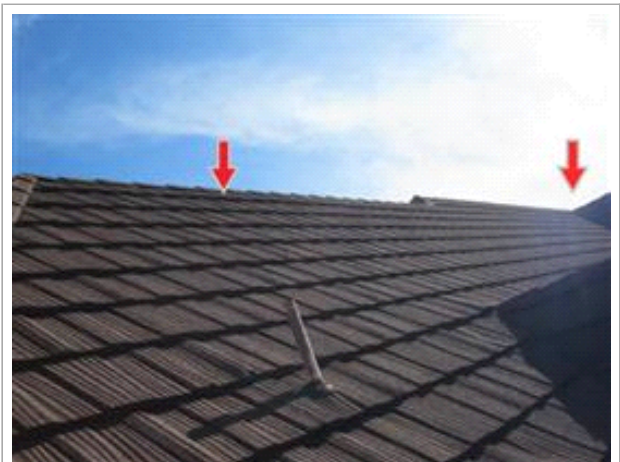
Figure Number 17

Limited ventilation system noted for attic area. Suggest installing off-ridge venting system to allow moisture and heat to escape from attic area. (See Figure #17)

Limited ventilation system noted for attic area. Suggest installing off-ridge venting system to allow moisture and heat to escape from attic area.

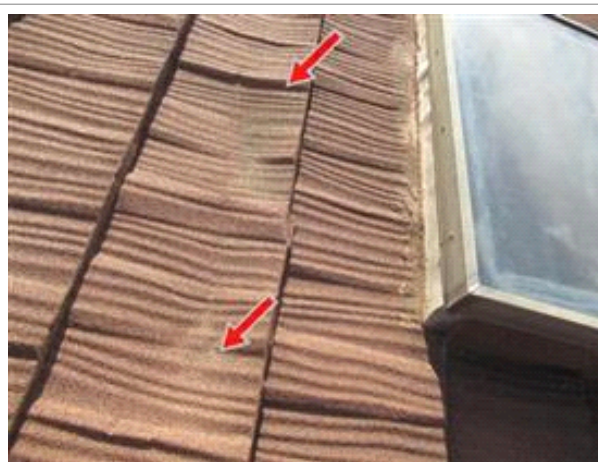
Figure Number 18

Damage to roofing materials due to prior impact from area being walked on improperly. (See Figure #18)

Damage to roofing materials due to prior impact from area being walked on improperly.

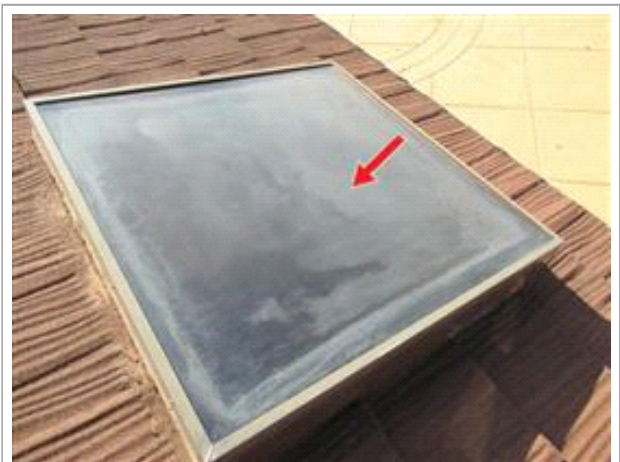
Figure Number 19

Sky light seal appears broken/fogged at rear patio of structure.

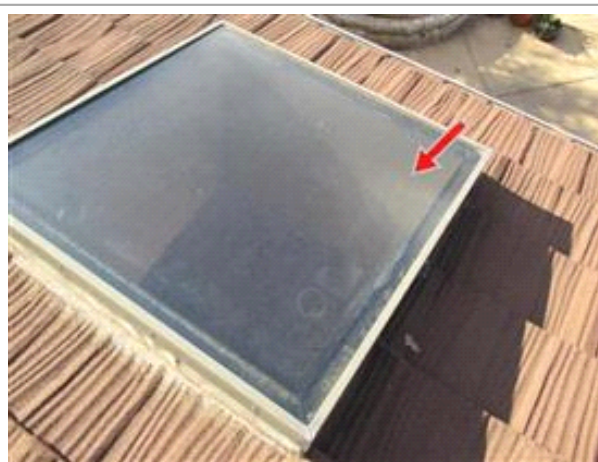
Figure Number 20

Sky light seal appears broken/fogged at rear patio of structure.

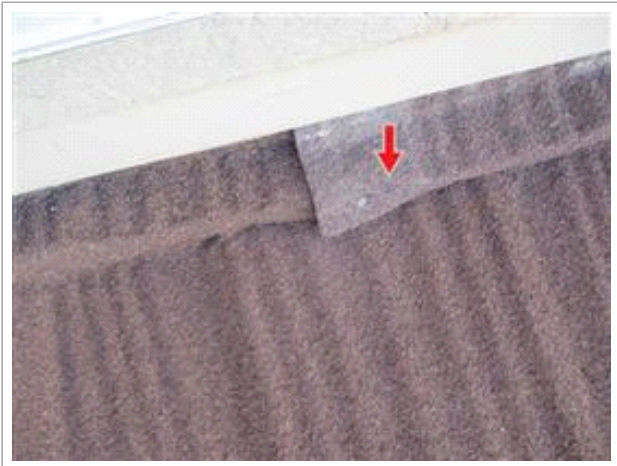
Figure Number 21

Nails loose & penetrated through flashing material at roof level.

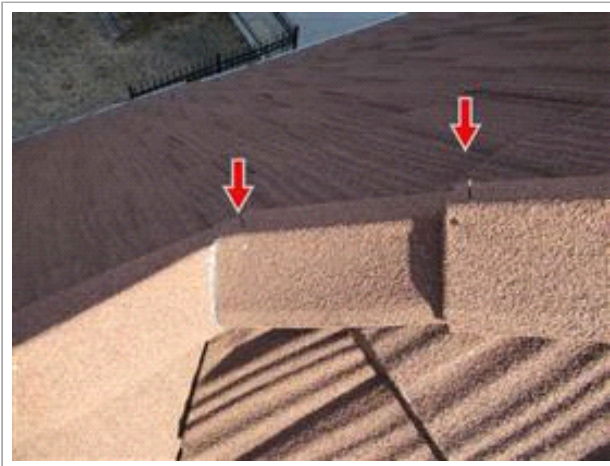
Figure Number 22

Nails loose & penetrated through flashing material at roof level.

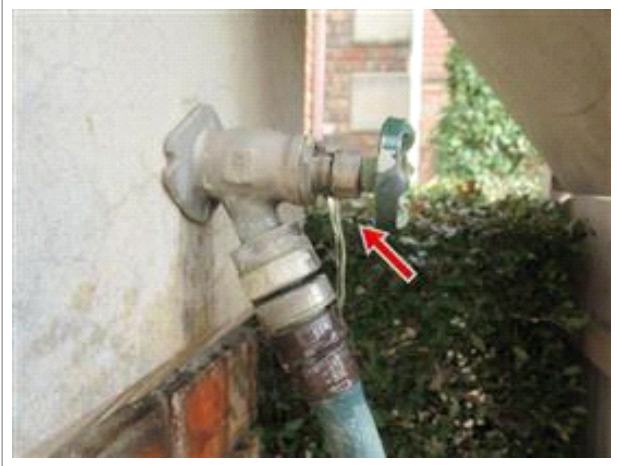
Figure Number 23

Leakage noted on hose bib at front & rear of structure while bib is turned on.

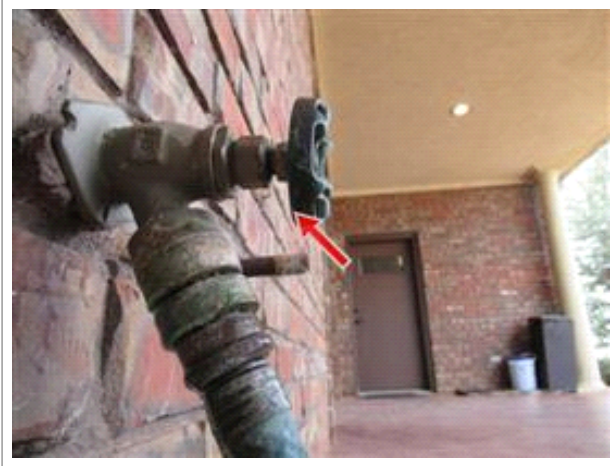
Figure Number 24

Leakage noted on hose bib at front & rear of structure while bib is turned on.

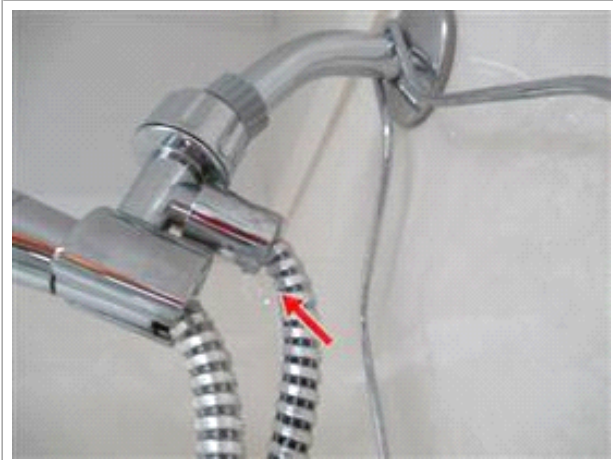
Figure Number 25

Leakage noted at shower head connection point located in upstairs hall bathroom area.

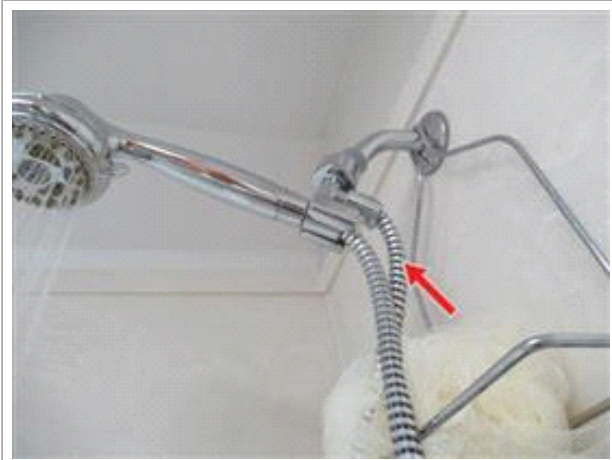
Figure Number 26

Leakage noted at shower head connection point located in upstairs hall bathroom area.

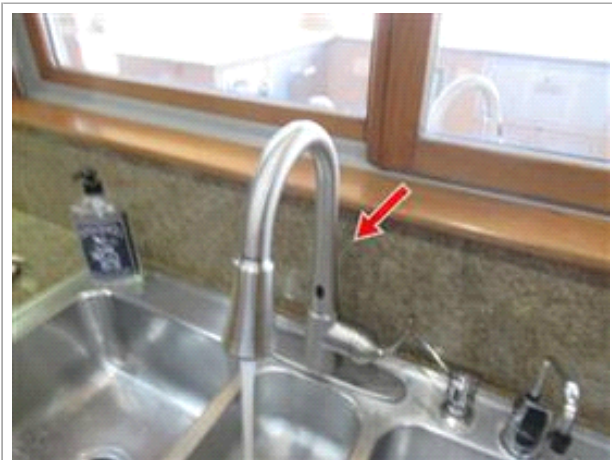
Figure Number 28

Touch control at kitchen sink faucet does not appear to operate. May need batteries replaced.

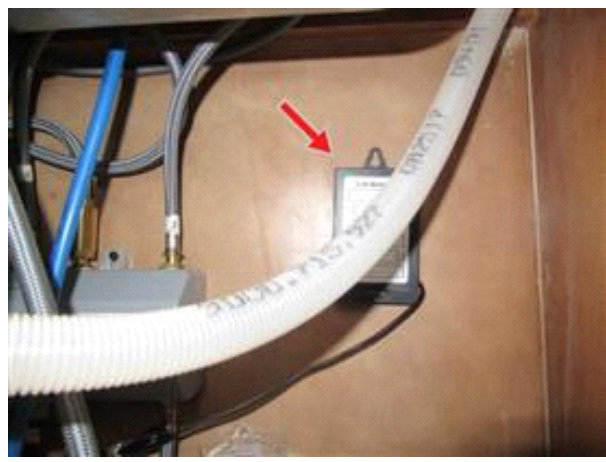
Figure Number 29

Touch control at kitchen sink faucet does not appear to operate. May need batteries replaced.

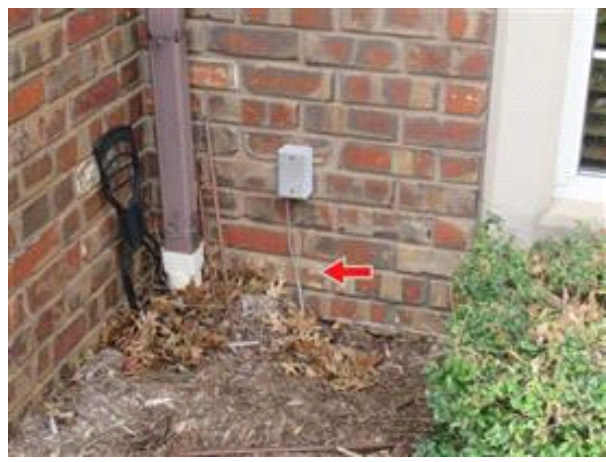
Figure Number 30

Improper wiring noted east exterior wall (romex wiring) should be in protective sheathing. (See Figure #30)

Improper wiring noted east exterior wall (romex wiring) should be in protective sheathing.

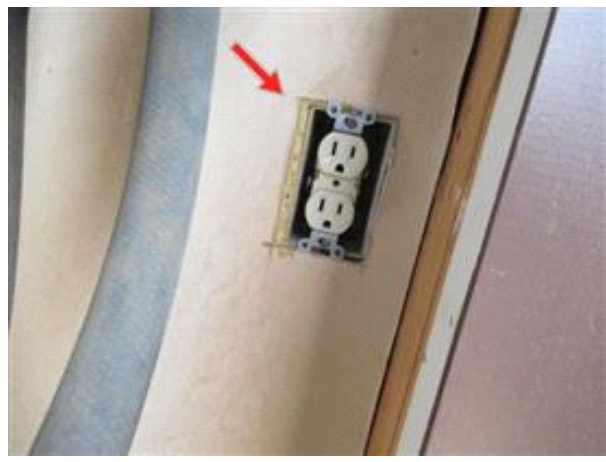
Figure Number 31

A few receptacle covers appear damaged/missing throughout structure.

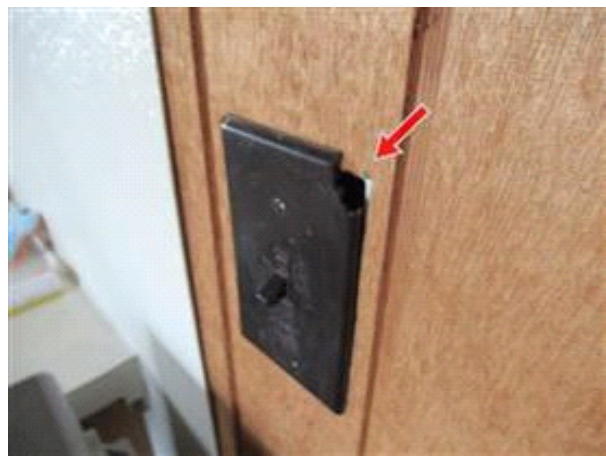
Figure Number 32

A few receptacle covers appear damaged/missing throughout structure.

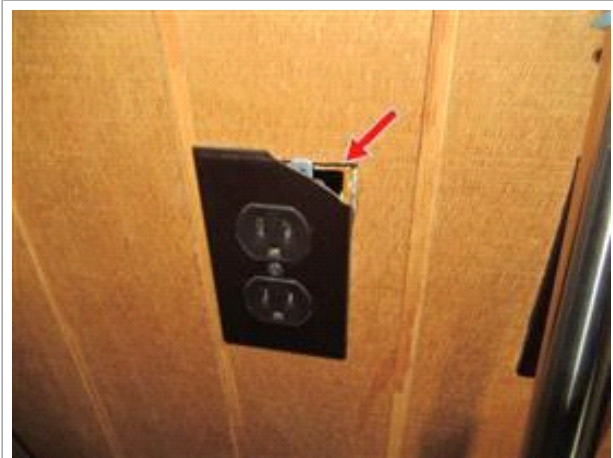
Figure Number 33

A few receptacle covers appear damaged/missing throughout structure.

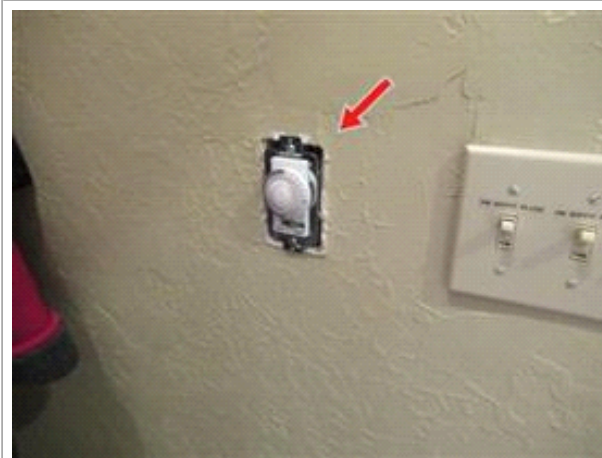
Figure Number 34

A few receptacle covers appear damaged/missing throughout structure.

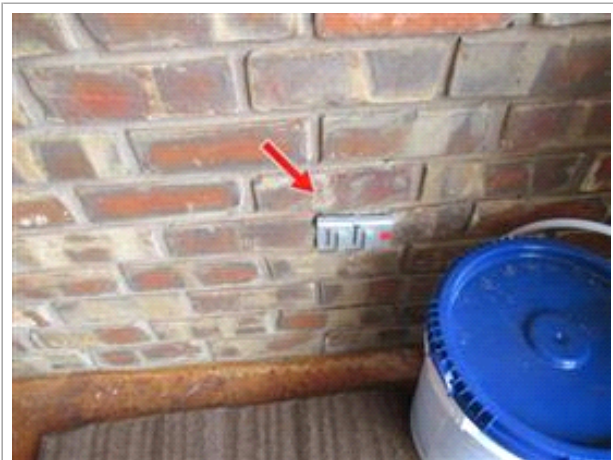
Figure Number 35

No ground fault circuit protection noted on electrical outlet at rear exterior wall. Since pool has been added all receptacles at rear of structure should be protected. (See Figure #35)

No ground fault circuit protection noted on electrical outlet at rear exterior wall. Since pool has been added all receptacles at rear of structure should be protected.

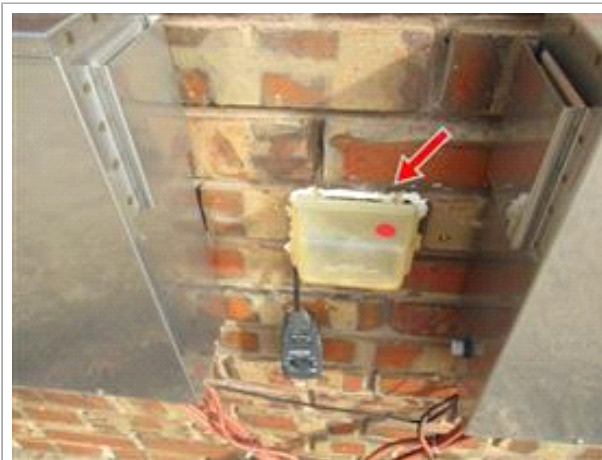
Figure Number 36

No ground fault circuit protection noted on a few exterior electrical outlets. Marked with a red dot. (See Figure #36)

No ground fault circuit protection noted on a few exterior electrical outlets. Marked with a red dot.

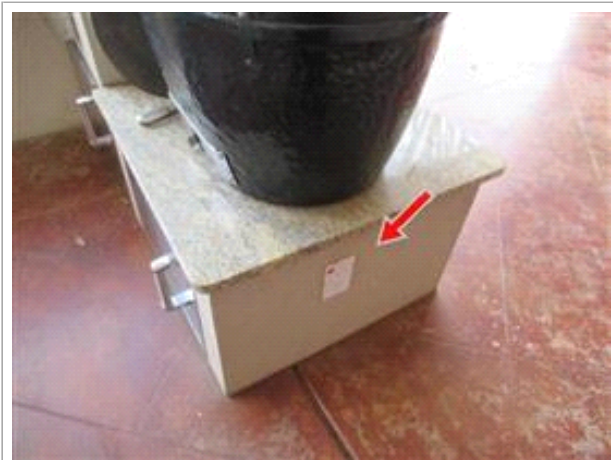
Figure Number 37

No power noted at a few receptacle(s) at exterior kitchen. Marked with red dot.

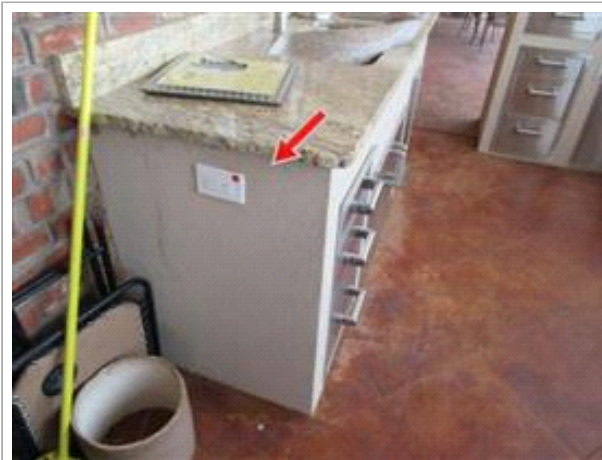
Figure Number 38

No power noted at a few receptacle(s) at exterior kitchen. Marked with red dot.

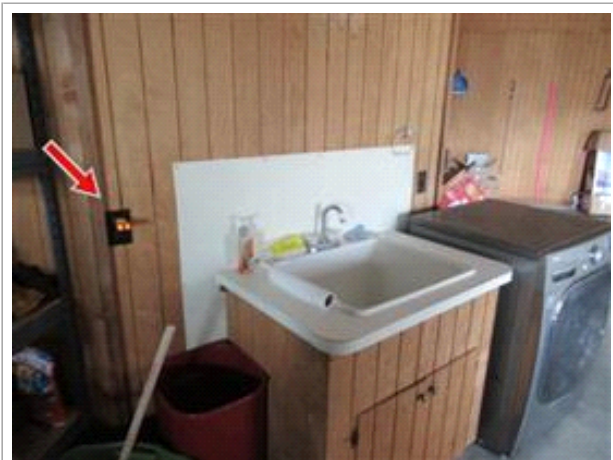
Figure Number 39

No GFI protection at some receptacles installed at garage areas. Due to the age of the structure all receptacles in the garage area should be protected unless set at a different height for freezer use. Marked with red dot.

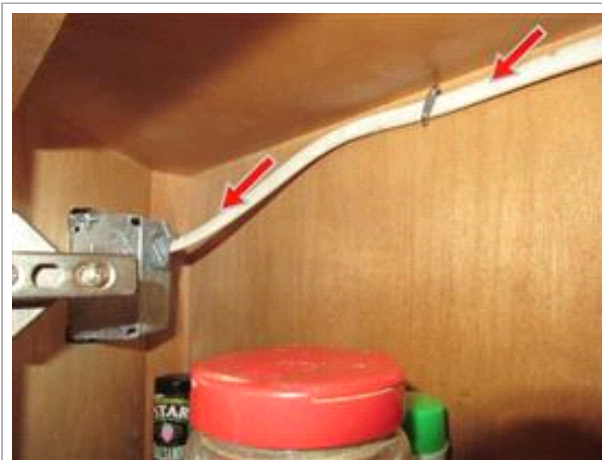
Figure Number 40

Improper wiring noted in island base cabinet in kitchen area (romex wiring) should be in protective sheathing. (See Figure #40)

Improper wiring noted in island base cabinet in kitchen area (romex wiring) should be in protective sheathing.

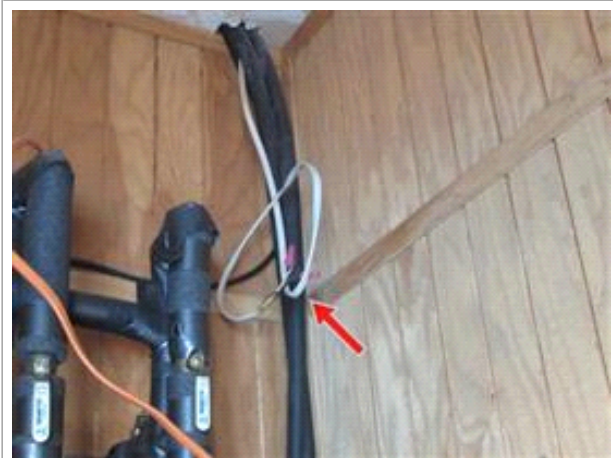
Figure Number 41

Wire splices do not appear to be properly installed in a junction box noted in water heater closet in pool house area. Correction needed. (See Figure #41)

Wire splices do not appear to be properly installed in a junction box noted in water heater closet in pool house area. Correction needed.

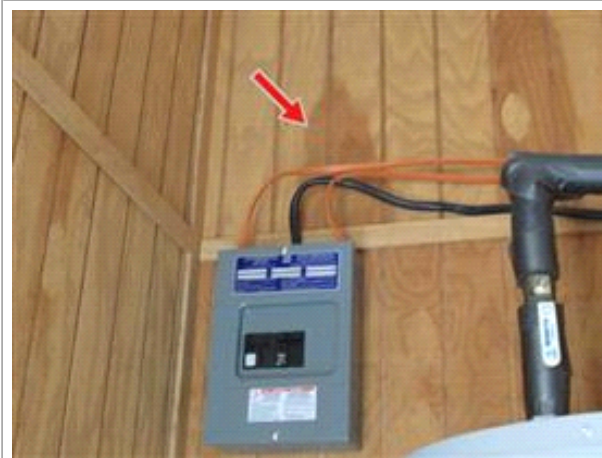
Figure Number 42

Improper wiring noted water heater closet on exterior at sub panel installed (romex wiring) should be in protective sheathing. (See Figure #42)

Improper wiring noted water heater closet on exterior at sub panel installed (romex wiring) should be in protective sheathing.

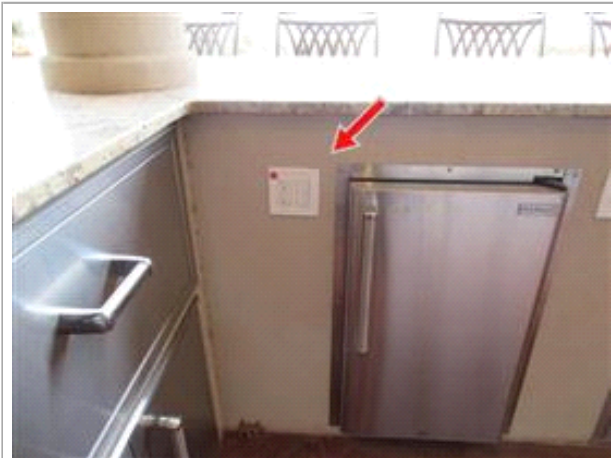
Figure Number 43

The ground fault circuit interrupter outlet in the rear exterior kitchen near refrigerator did not trip when tested.

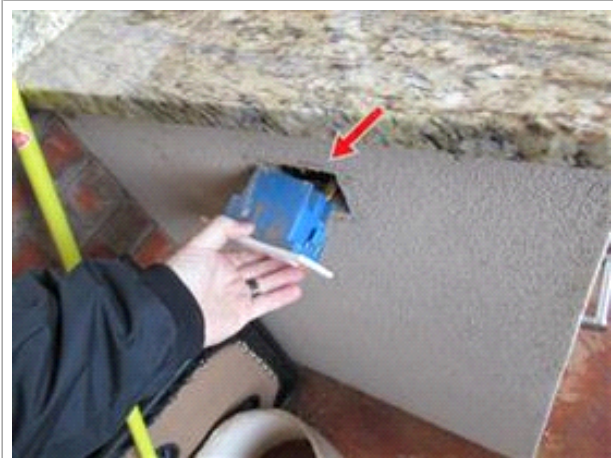
Figure Number 45

Loose electrical box noted at exterior kitchen left side of sink. (See Figure #45)

Loose electrical box noted at exterior kitchen left side of sink.

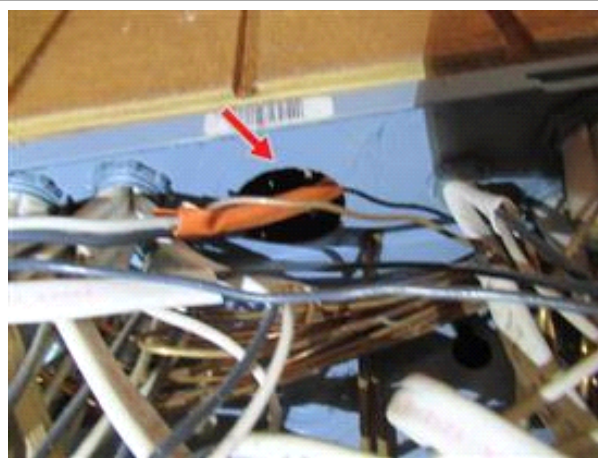
Figure Number 46

Missing panel bushings at added wiring in main panel area.

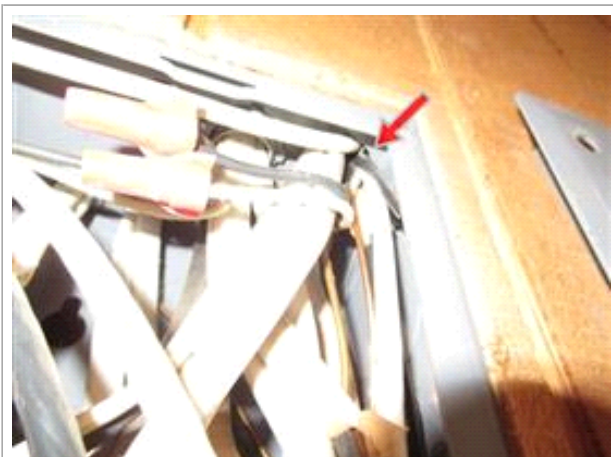
Figure Number 47

Missing panel bushings at added wiring in main panel area.

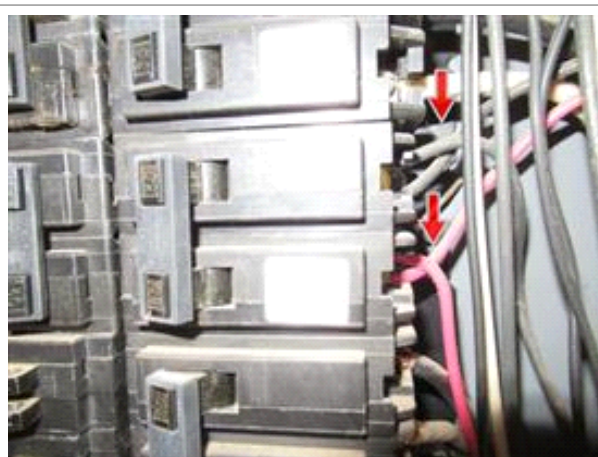
Figure Number 48

220 amp breaker appears to be double tapped in main panel. These breakers are not rated for such and the provision of new breaker is recommended. (See Figure #48)

220 amp breaker appears to be double tapped in main panel. These breakers are not rated for such and the provision of new breaker is recommended.

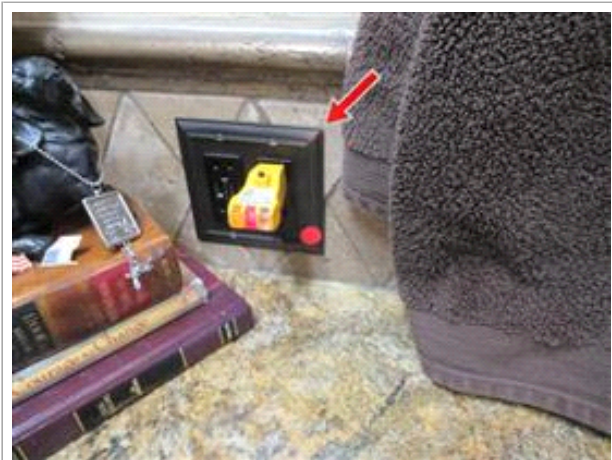
Figure Number 49

Reverse polarity noted at receptacle(s) in master bathroom (right of sink). Marked with red dot.

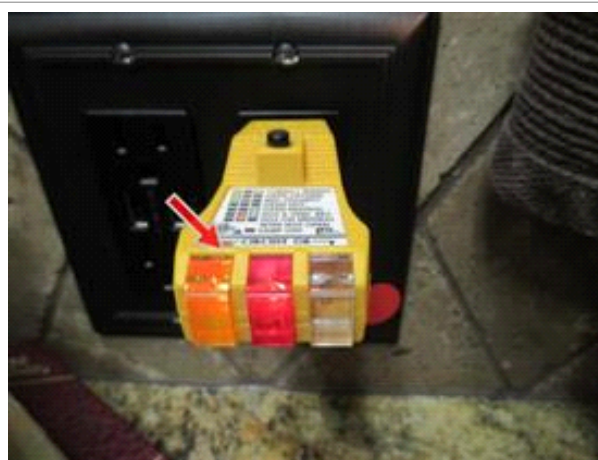
Figure Number 50

Reverse polarity noted at receptacle(s) in master bathroom (right of sink). Marked with red dot.

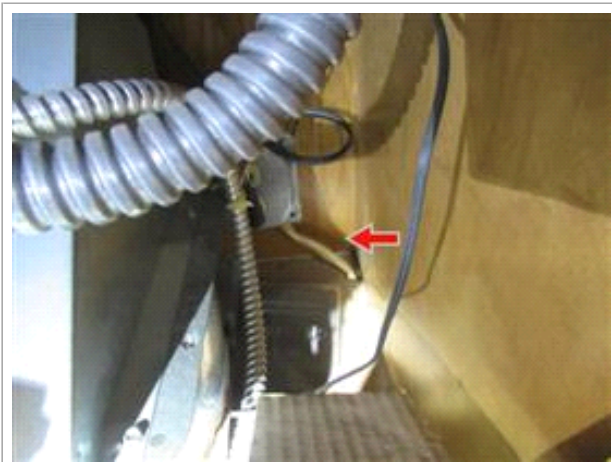
Figure Number 51

Improper wiring noted in cabinet below cook top (romex wiring) should be in protective sheathing or inside wall cavity. (See Figure #51)

Improper wiring noted in cabinet below cook top (romex wiring) should be in protective sheathing or inside wall cavity.

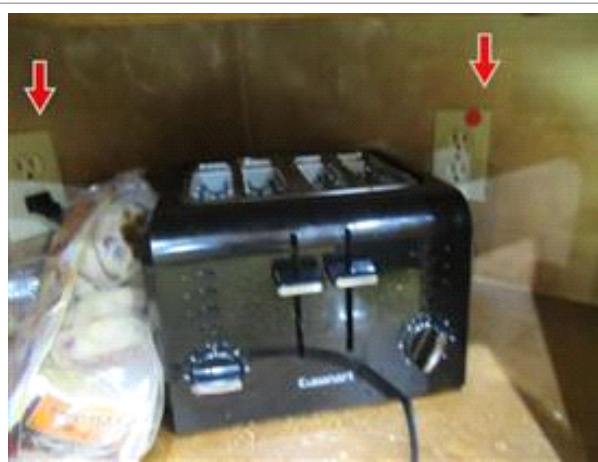
Figure Number 52

No ground fault circuit protection noted on electrical outlet at left side of kitchen sink (a toaster cubby). (See Figure #52)

No ground fault circuit protection noted on electrical outlet at left side of kitchen sink (a toaster cubby).

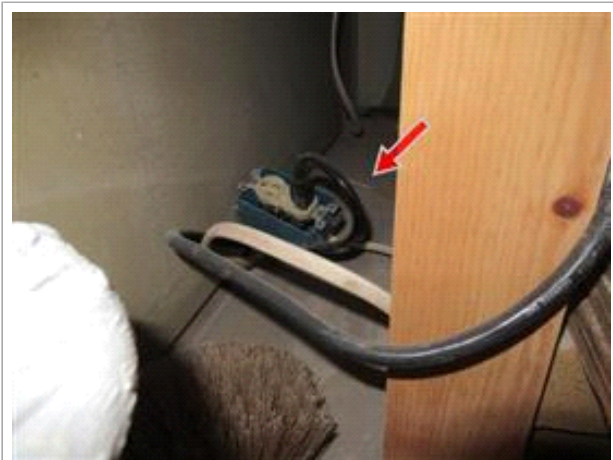
Figure Number 53

The electrical box located under the jacuzzi tub should be secured to studs not laying on ground with no receptacle cover. Suggest repairing & installing. (See Figure #53)

The electrical box located under the jacuzzi tub should be secured to studs not laying on ground with no receptacle cover. Suggest repairing & installing.

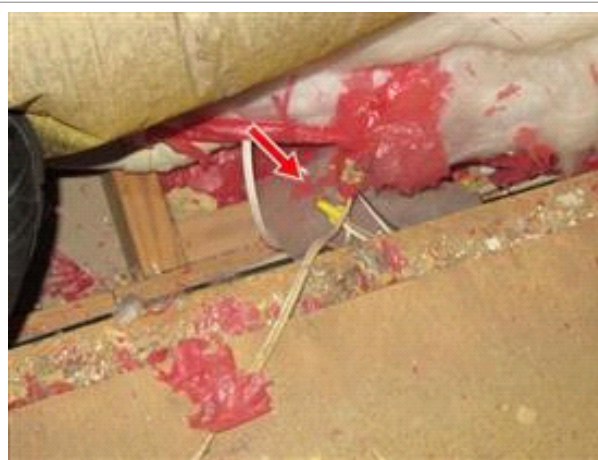
Figure Number 54

Wire splices do not appear to be properly installed in a junction box noted in attic area. Correction needed. (See Figure #54)

Wire splices do not appear to be properly installed in a junction box noted in attic area. Correction needed.

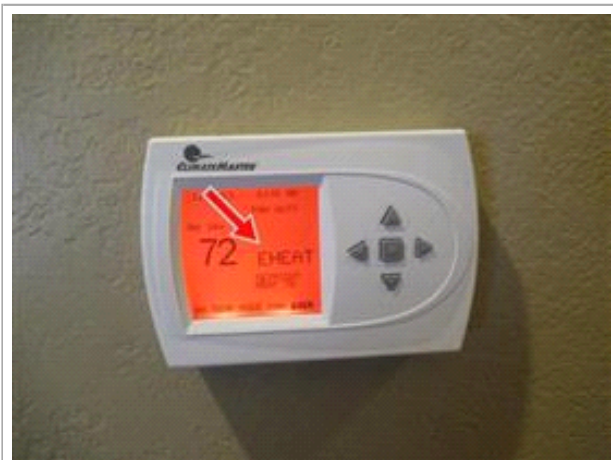
Figure Number 55

Heat strips (in emergency heat mode) do not appear to be operating as intended for main zone. Evaluation by HVAC contractor suggested.

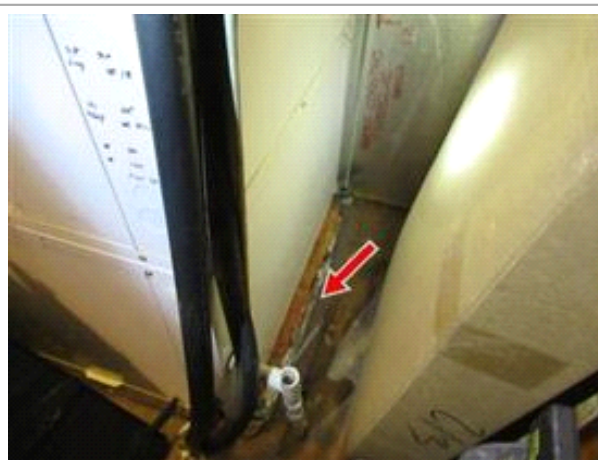
Figure Number 56

No float switch or secondary drain pan noted at unit at second floor level. Evaluation by a HVAC contractor suggested. (See Figure #56)

No float switch or secondary drain pan noted at unit at second floor level. Evaluation by a HVAC contractor suggested.

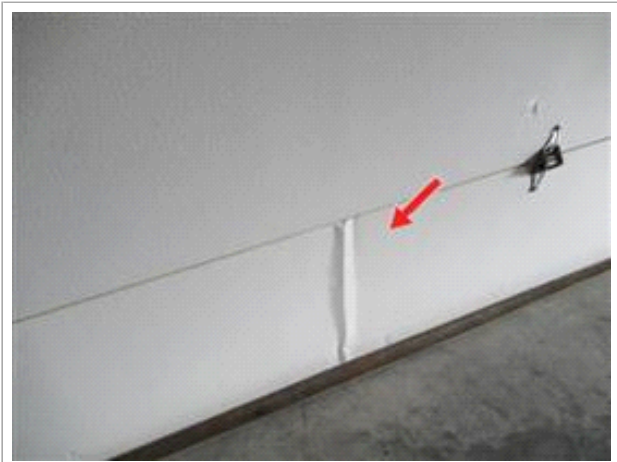
Figure Number 57

Damage located to lower panel of double garage door. (See Figure #57)

Damage located to lower panel of double garage door.

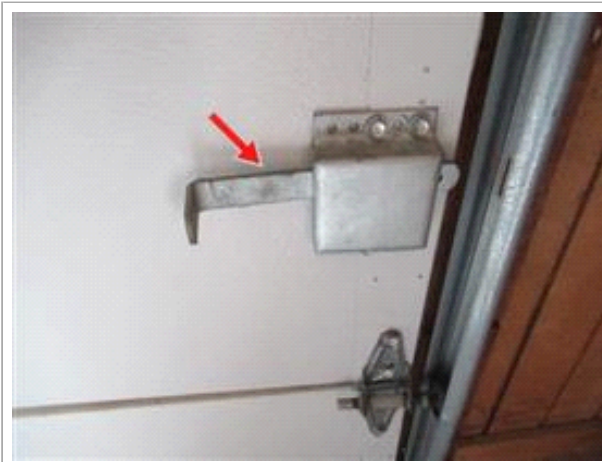
Figure Number 58

Garage door looking mechanism should be removed from door or made inoperable when a garage door opener is installed. Repair and replace as needed. (See Figure #58)

Garage door locking mechanism should be removed from door or made inoperable when a garage door opener is installed. Repair and replace as needed.

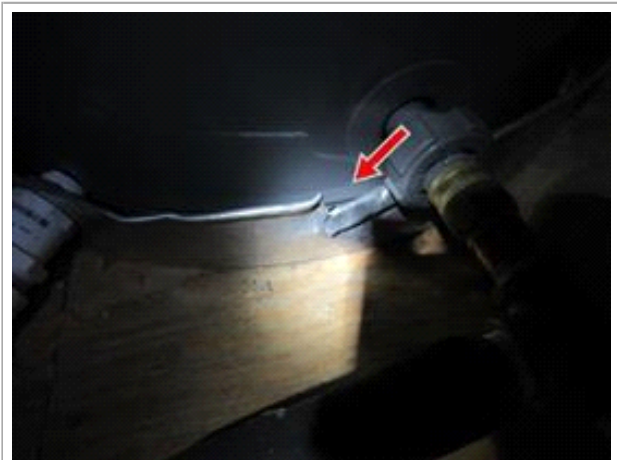
Figure Number 59

Pan for water heater appears to be slightly damaged in garage area. (See Figure #59)

Pan for water heater appears to be slightly damaged in garage area.

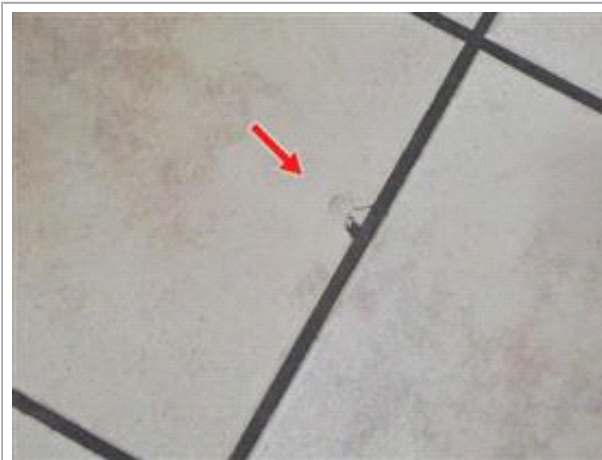
Figure Number 60

Loose/Hollow tile(s) at kitchen. Suggest re-securing. (See Figure #60)

Loose/Hollow tile(s) at kitchen. Suggest re-securing.

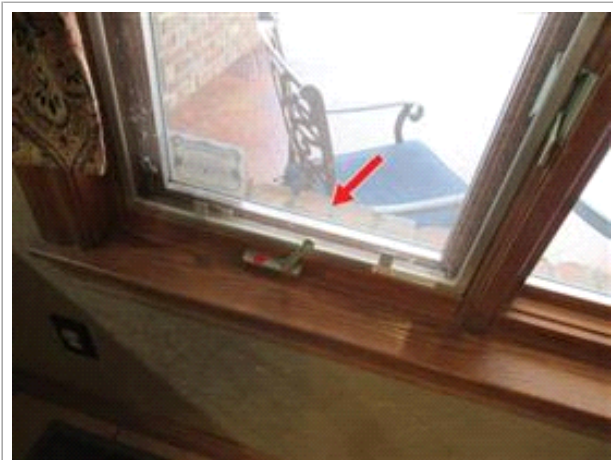
Figure Number 61

Damaged opening mechanism at window that appears to have water damage to sill plate in second level east bedroom area. Marked with red dot.

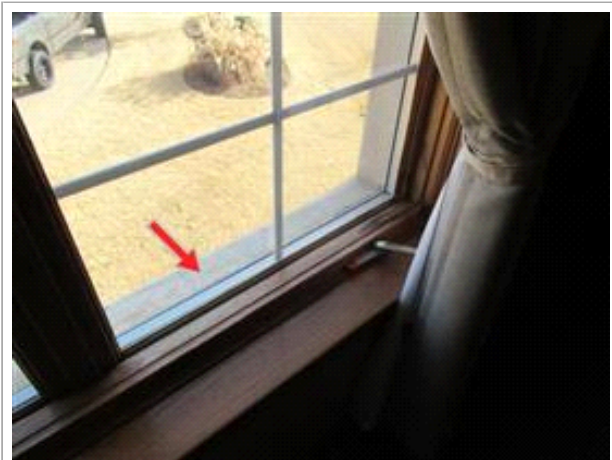
Figure Number 62

Damaged opening mechanism at window that appears to have water damage to sill plate in second level east bedroom area. Marked with red dot.

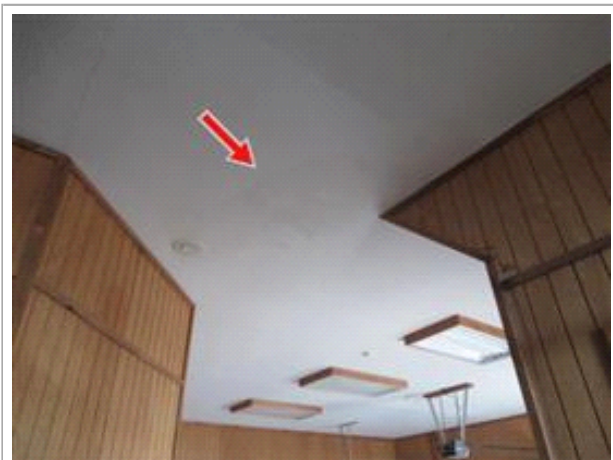
Figure Number 63

Ceiling surface damage noted in living room & garage areaa along with prior leakage. No high moisture levels noted. Budget cosmetic repairs.

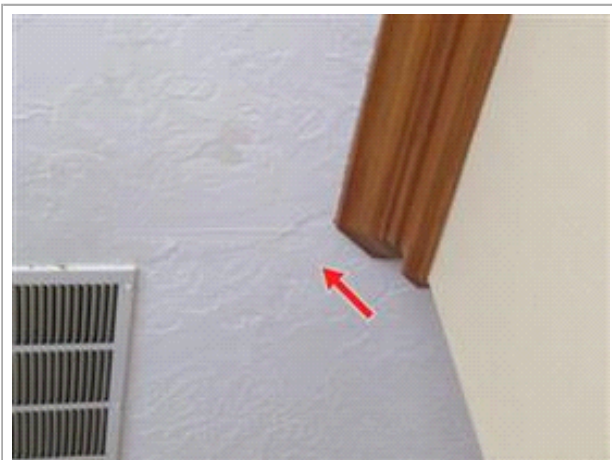
Figure Number 64

Ceiling surface damage noted in living room & garage areaa along with prior leakage. No high moisture levels noted. Budget cosmetic repairs.

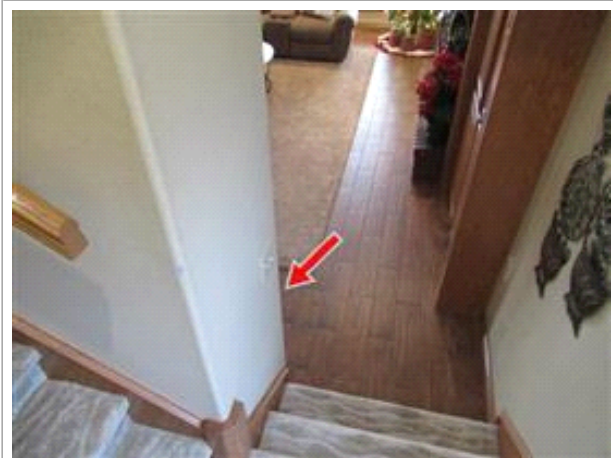
Figure Number 65

Hand rails are required at any steps that have two or more risers, hand rails are missing at the base of staircase area. (See Figure #65)

Hand rails are required at any steps that have two or more risers, hand rails are missing at the base of staircase area.

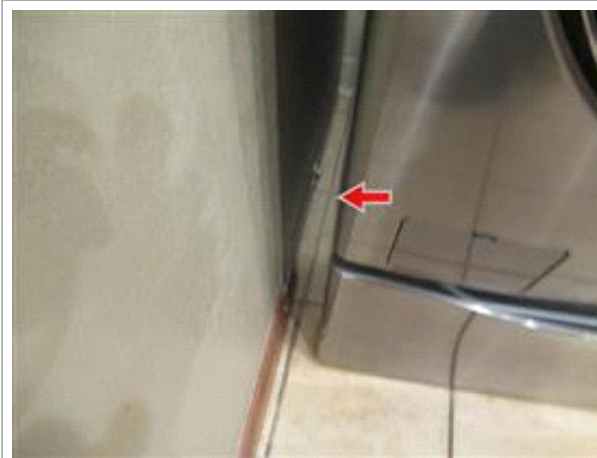
Figure Number 66

Baseboard appear to be missing in laundry room area. (See Figure #66)

Baseboard appear to be missing in laundry room area.

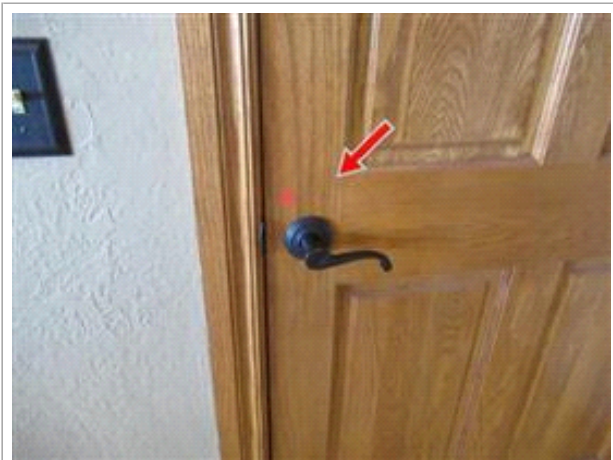
Figure Number 67

A few of the interior doors need striker plate adjustment or minor repairs in order to close properly. Marked with a red dot. (See Figure #67)

A few of the interior doors need striker plate adjustment or minor repairs in order to close properly. Marked with a red dot.

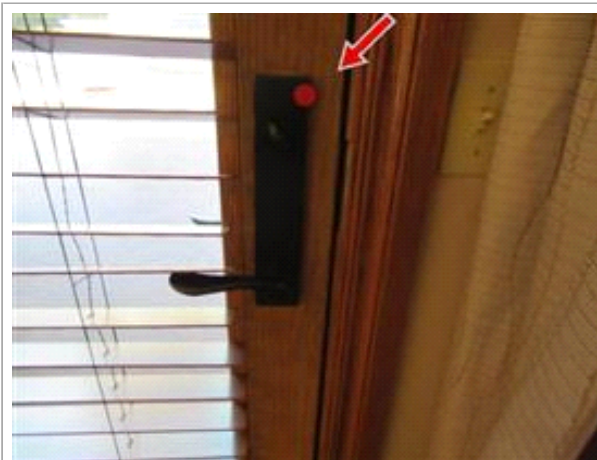
Figure Number 68

Dead bolt would not latch properly (works intermittently) at master bedroom rear entry door. Marked with red dot.

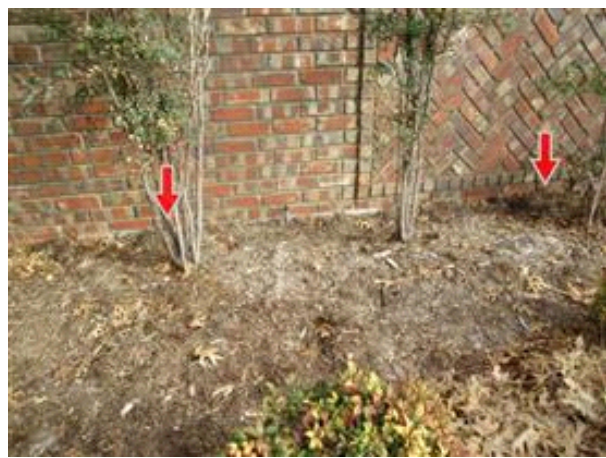
Figure Number 69

Mulch bed appears to be too high on east side(s) of structure. Suggest regrading to expose 2-4 inches of foundation.
