Phone: (580) 351-0484
Fax: (580) 353-6326
haubrickhomeinspections.com

Standard Inspection Report For: John Doe

481 NE Windy Ridge, Lawton, Ok

Date of Inspection: 12/18/2018

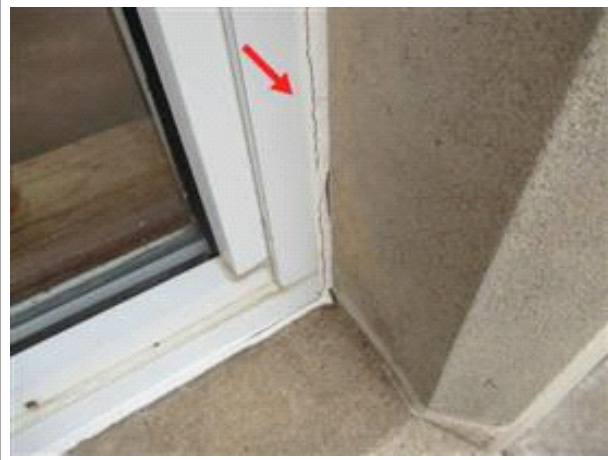
Figure Number 1

A few windows & door opening appear to need caulking touched-up on exterior of structure.

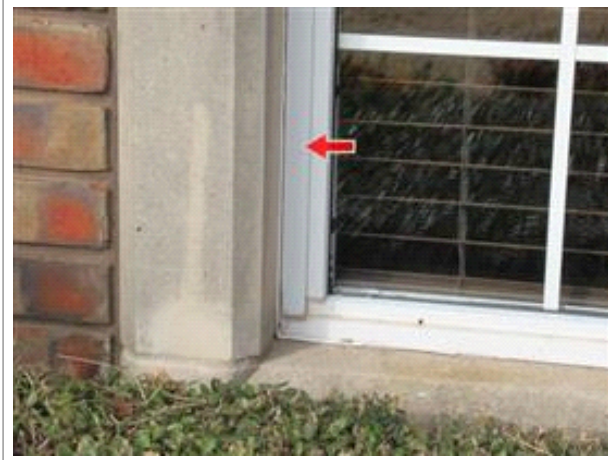
Figure Number 2

A few windows & door opening appear to need caulking touched-up on exterior of structure.

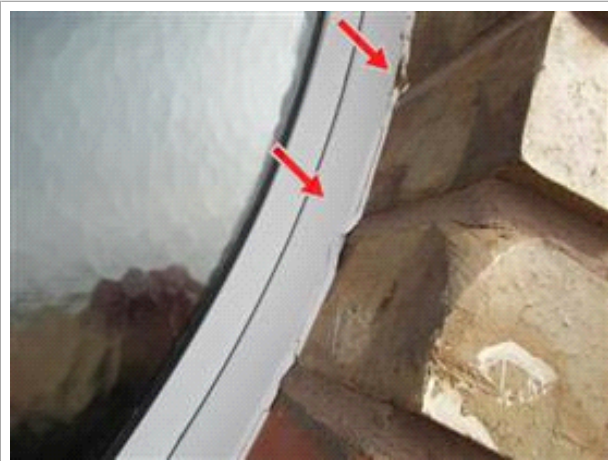
Figure Number 3

A few windows & door opening appear to need caulking touched-up on exterior of structure.

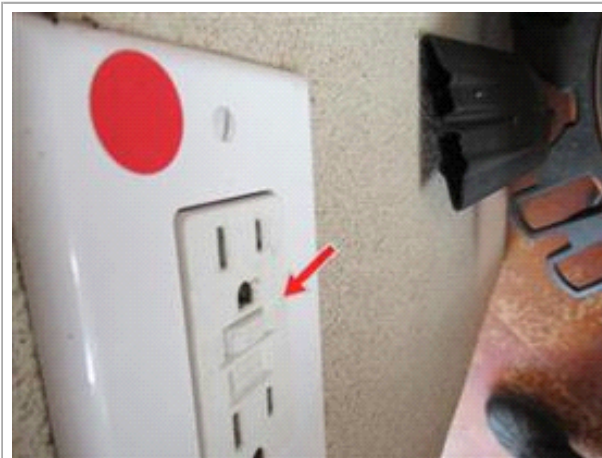
Figure Number 44

The ground fault circuit interrupter outlet at the rear exterior kitchen was tripped before testing and would not reset.

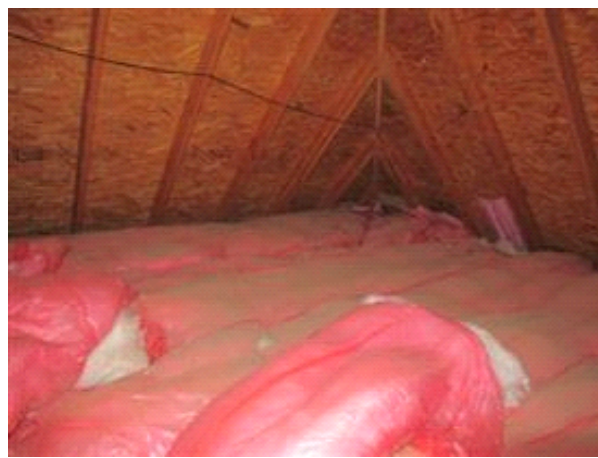
Figure Number 70

Attic was inspected for proper insulation & ventilation system in place.

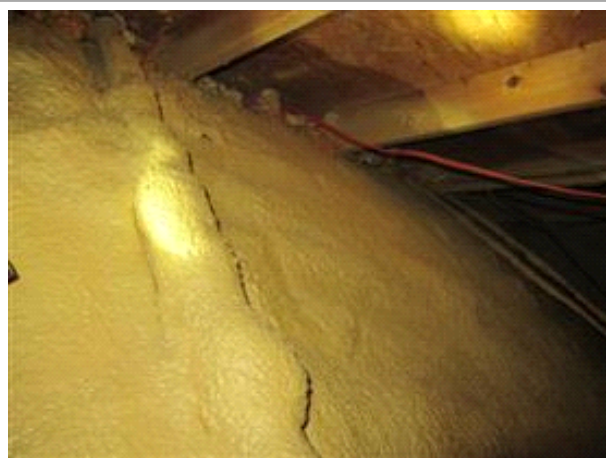
Figure Number 71

Attic was inspected for proper insulation & ventilation system in place.

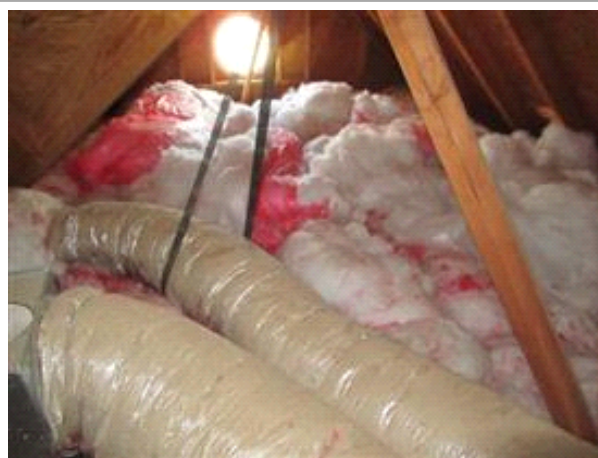
Figure Number 72

Attic was inspected for proper insulation & ventilation system in place.

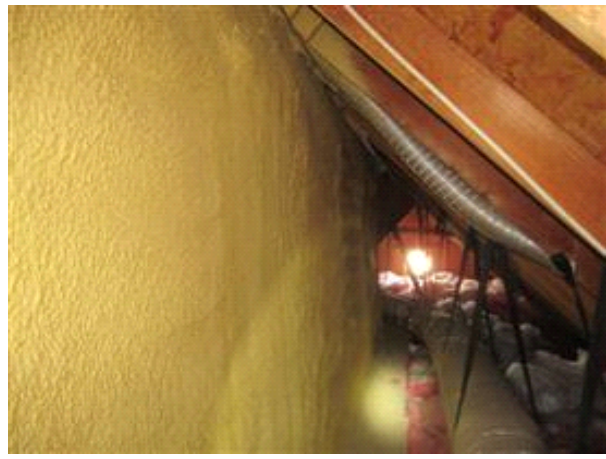
Figure Number 73

Attic was inspected for proper insulation & ventilation system in place.

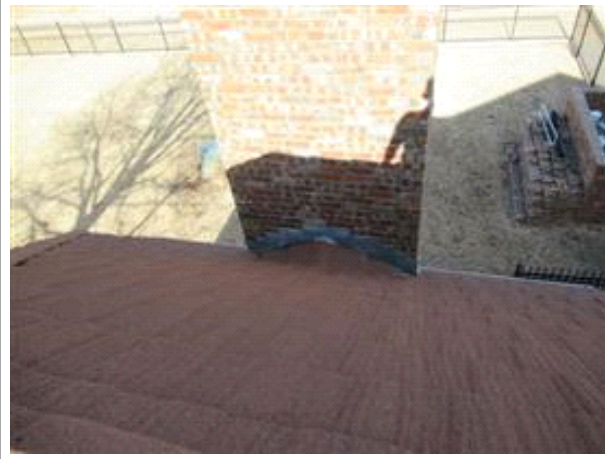
Figure Number 74

Cricket saddle noted behind chimney stack at roof level.

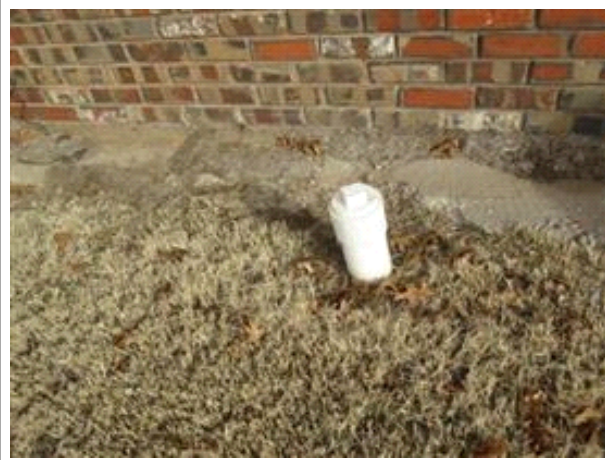
Figure Number 76

Clean-out was located, cap removed & viewed for proper flow of sewer system. No blockage noted at time of inspection.

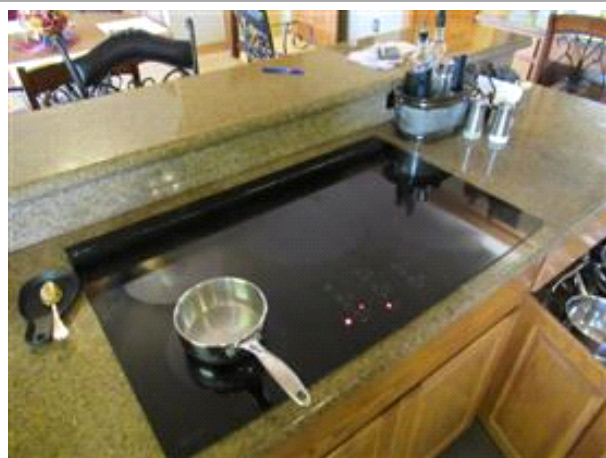
Figure Number 79

Kitchen appliances were checked for proper operation & installation.

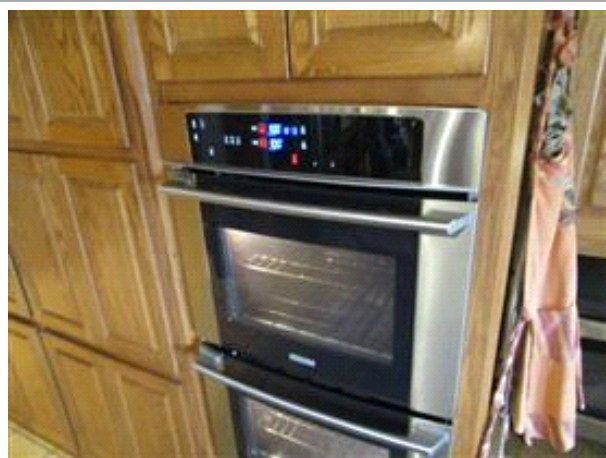
Figure Number 80

Kitchen appliances were checked for proper operation & installation.

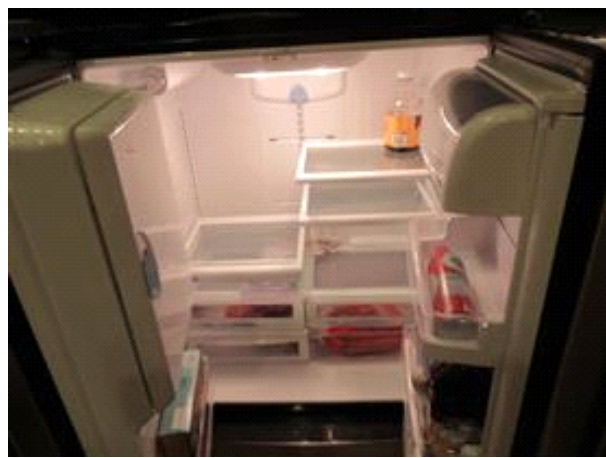
Figure Number 81

Kitchen appliances were checked for proper operation & installation.

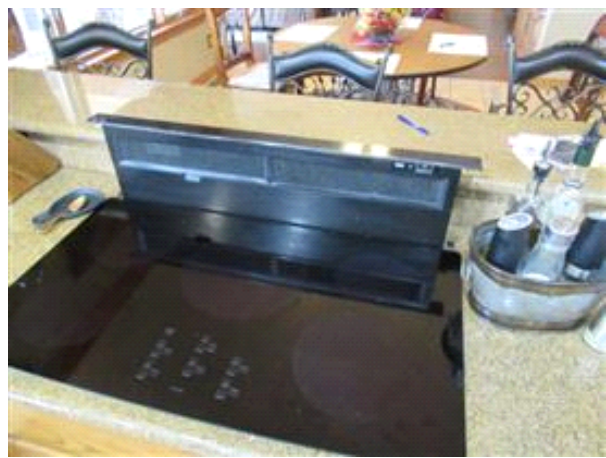
Figure Number 82

Kitchen appliances were checked for proper operation & installation.

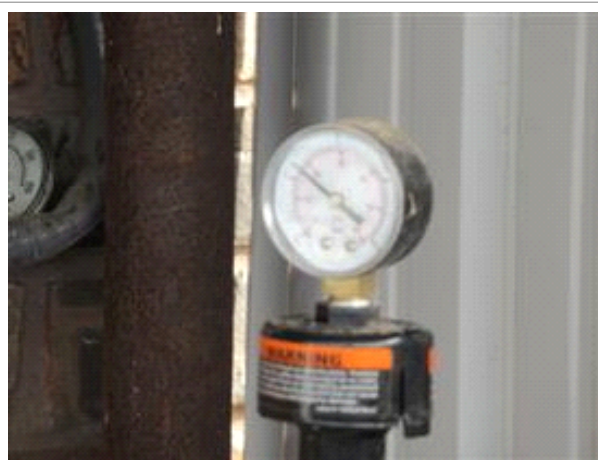
Figure Number 86

Pool pumps & equipment where visually checked for proper installation and operation. Pool pump for slide was not in operation. Heater and systems should be inspected by a professional in this area.

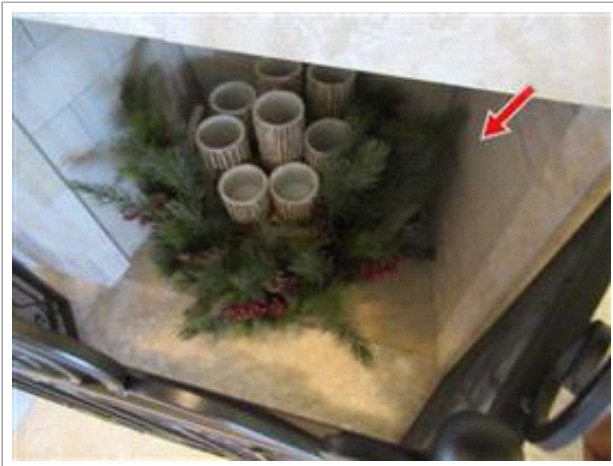
Figure Number 89

Fire box was not tested in formal living room due to pants inside unit at time of inspection.

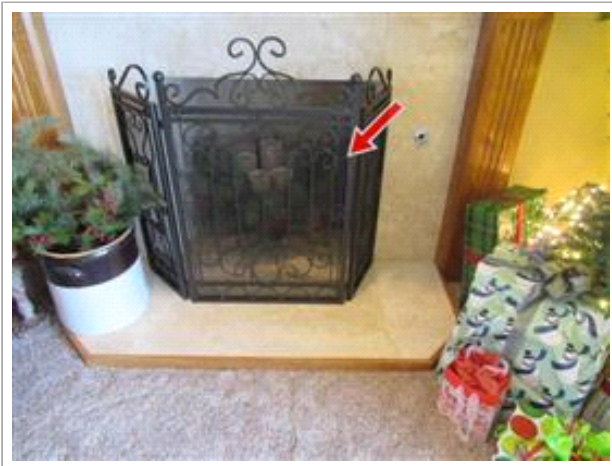
Figure Number 90

Fire box was not tested in formal living room due to pants inside unit at time of inspection.

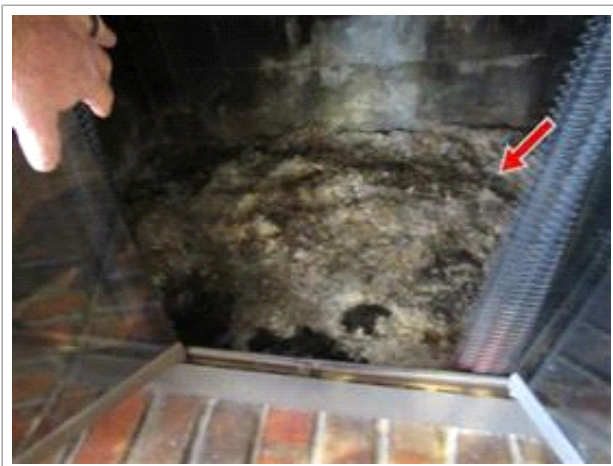
Figure Number 91

Fireplace floor was covered with ashes. This limited our inspection. Consult a specialist.
